# SERVICE BULLETIN SPSB009

SUBJECT: SUPPLIER/VENDOR RECALL OF PS70104 HOUSINGS (METAL FLEX HOISING INC)

STATUS: MANDATORY INSPECTION AND REPLACEMENT OF RECALLED HOUSINGS

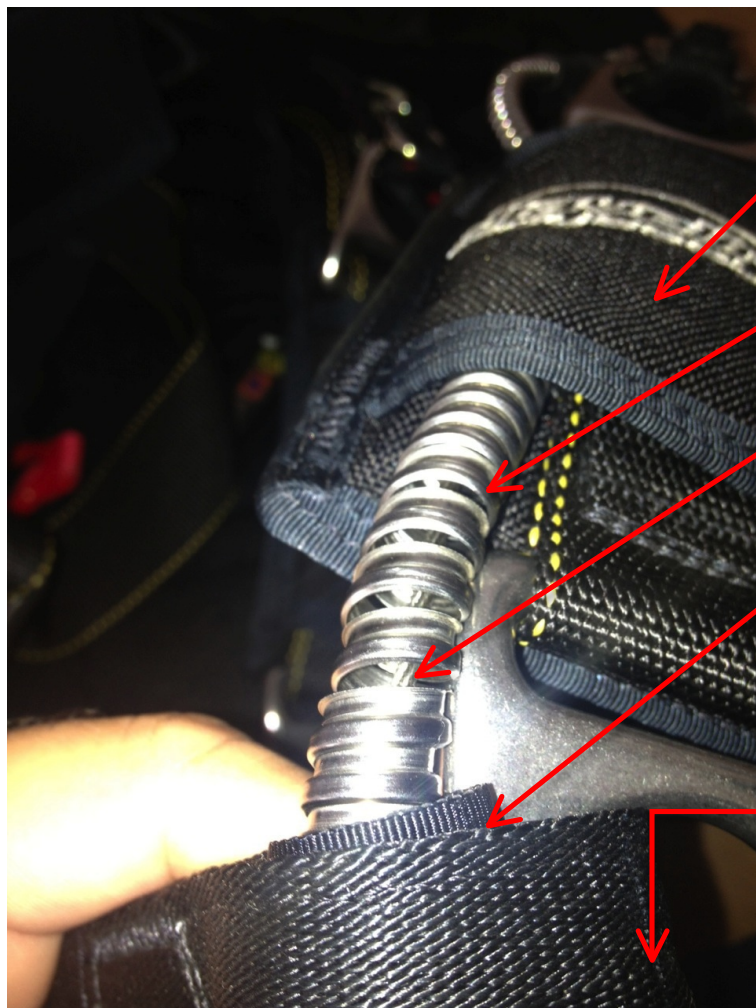
## **WEARERS LEFT SIDE:**

RESERVE RIPCORD HOUSING (LOWER END)

SEPERATED HOUSING (FOR REFERENCE)

If the serial number is listed in the above table, inspect the available exposed reserve ripcord housing. Locate the lower end of the housing, which is clamped to the Main Lift Web, just above the reserve ripcord pocket. Inspect the exposed length of housing from the clamp upwards; ensure that the coil has not separated/unraveled. Be sure to inspect the section that is routed through the chest strap.

A. **HOUSING FOUND TO BE INTACT (GOOD):** The rig may continue to be jumped with periodic monitoring until the next repack cycle or earlier elective replacement. However this housing must be replaced at the next repack cycle. See <http://www.sunpath.com/support/HousingReplacement.pdf> for instructions for your rigger to complete the replacement of the housing.

B. HOUSING FOUND TO BE SEPERATED/UNRAVELLED (BAD): The housing must be replaced before the next jump by a certificated senior or master parachute rigger (or foreign equal) or the manufacturer. See <http://www.sunpath.com/support/HousingReplacement.pdf> for instructions for your rigger to complete the replacement of the housing or instructions to send your system back to the manufacturer.
